Fire Risk Assessment

Halliford School

Organisation / Responsible Person:	Halliford School.
Industry / Trade:	Independent day school for boys aged 11-18 years, and girls aged 16-18 years.
Premises Address:	PHILIP COTTAM CENTRE & DT WORKSHOP/STORES, Halliford School, Russell Road, Shepperton, Middlesex TW17 9HX.
Persons Consulted:	Elspeth Sanders – Bursar, Halliford School. Darren Macefield – Premises Manager, Halliford School.
Fire Risk Assessor:	Adam Webb – Risk Services Director, Hettle Andrews.
Date of Fire Risk Assessment:	12 April 2022.
Date of previous Fire Risk Assessment:	16 February 2021.
Date recommended for Review*:	April 2023.
Excluded / Inaccessible Areas:	Roof spaces/ voids, storeroom F02 off the drama studio on the first floor, and the COSHH cupboard in the large Art Studio were not able to be accessed/reviewed during the site inspection, and as such these areas are excluded from the scope of this fire risk assessment.
Relevant Legislation / Guidance:	Regulatory Reform (Fire Safety) Order 2005. Building Regulations 2010 and associated guidance. Fire safety risk assessment: educational premises. Fire safety risk assessment: small/medium places of assembly.

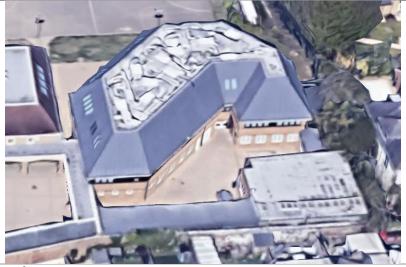
Photograph / Aerial View of Premises:

← Philip Cottam Centre

\leftarrow DT workshop and stores
